**SUMMARY:**

**CLASS 15F 3046 'VRENI':**

**CLASS 15CA 2056 'INGE':**

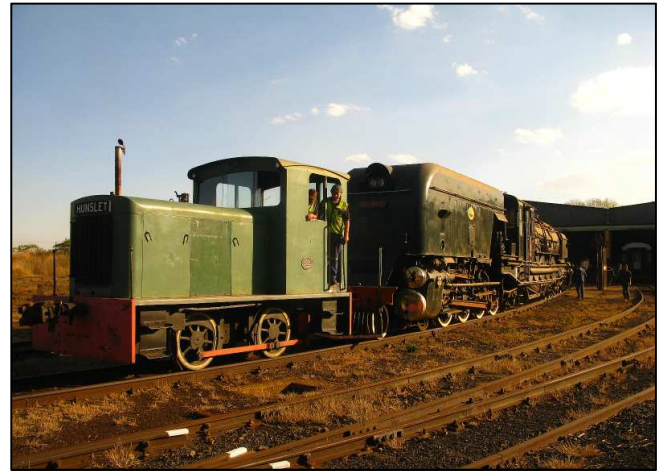
P02 - The GMA/M being moved to storage pending further arrangements concerning the wheel profiling work. 15F 3052 would be moved into the just-vacated bay for repairs.

- David Shepherd's Class 15F 3052 (Care of Sandstone Estates) has been moved from the old Running Shed and has swapped places with GMA/M 4079 into the 15M Workshops.
- The GMA/M locomotive has been moved up for staged storage to the old Running Shed until the protracted negotiations and arrangements concerning the delivery of replacement axles, correcting their profiles, fitting them and the payment for the work to be done is concluded.

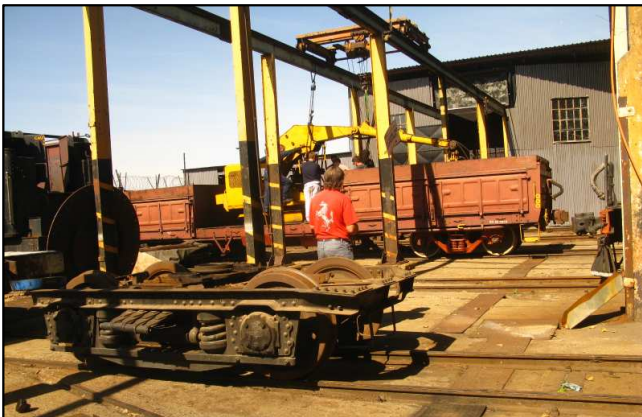
- Upon the Donor Bogie, the bolster pivot and the shoulder pads were cleaned up, including their wear plates and washers.
- Upon an attempt to fill the pivot boss with oil; the presence of a crack was revealed as the oil leaked through. So, it needs to be stripped and degreased for inspection, and either re-welded or replaced.

P03 - Engineering Apprentices being guided on removing the hydraulic rams from the Coal Grab. In the foreground is the Locomotion Bogie after bolster hardware cleaning.

- The Africa Academy apprentices were assigned the task of removing and stripping the two hydraulic rams for the DZ-wagon 'Coal Grab's boom. This was done under the supervision of Shaun Ackerman as a specific engineering training exercise. They will also be doing the overhaul and reinstallation.

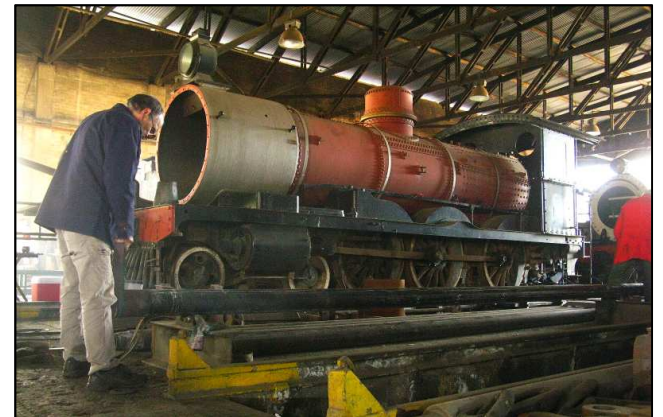
P04 - With Class 6A 473 'Charlotte' in the background, Danie Gouws de-scales the front end of one of 15CA 2056's new boiler flues with a strip of emery cloth.

- Last week's batch of freshly annealed boiler super-heater flues were descaled and deburred while being cleaned up for installation.
- A second start had been made on cutting and planing the wood for component painting racks for the 15CA project. The first lot of wood was mistakenly used for fire lighting kindling for the recent training session! (Oops!) Hannes Bester was NOT pleased!
