**SUMMARY:**

A shorter work day today as our first Open Day 2017 Planning Meeting was held in the morning.

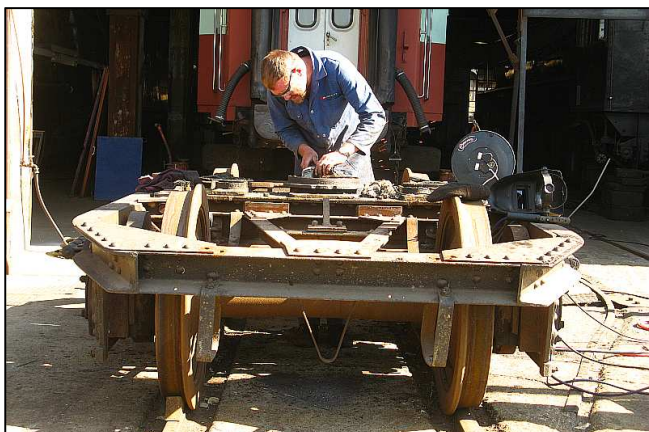
P01 - Grinding the new welds on the cup-shaped boss for the Locomotion Coach’s bolster pivot.

- The ‘cracked’ boss on the Locomotion Coach bogie was actually gouged by the wear washer and oil was leaking through the pores of the cast iron. It was pre-heated and welded to seal the cup.

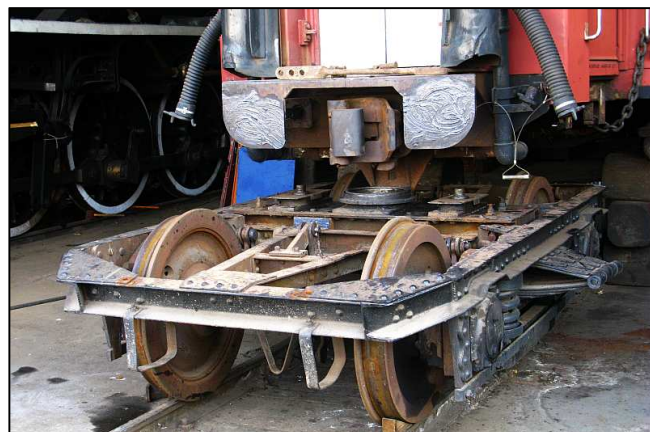
P02 - The multistage process of rolling the bogie under the coach again, complicated by limited jacking heights.

- The bogie has been rolled back under the Sandstone Locomotion Coach and the coach lowered again, but it remains to connect the bogie up properly. (Not a big job.)

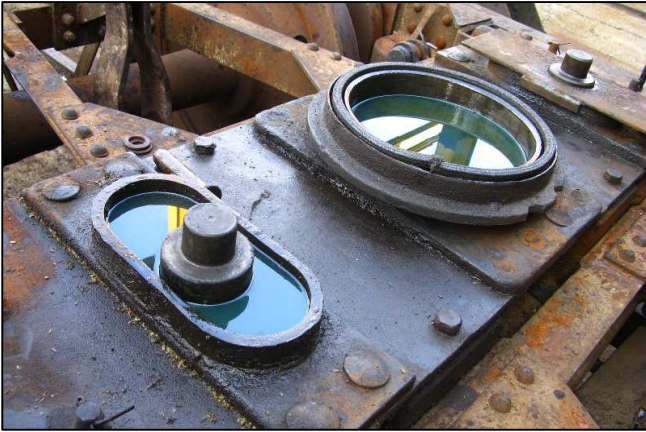
P03 - The newly repaired boss now holds oil as designed. Square-section graphite packing was installed as a seal.

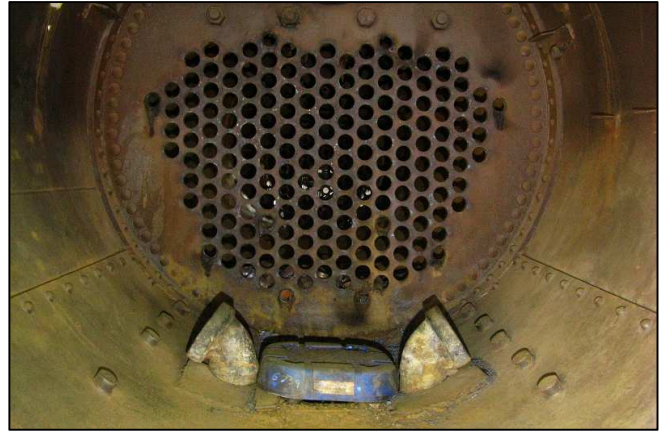
P04 - Class 6A 473 Charlotte's simple front tube plate after having had all the boiler tubes removed.

- Class 15F 3046 ‘Vreni’ was pulled out over the ash-pits and given her routine smokebox clean, and the first half of a boiler washout. (We ran out of time.)
- Class 6A 473 ‘Charlotte’ had had all of the boiler tubes withdrawn during the week. The job was a difficult one as the tubes had been over-expanded and were bulging behind the plates.
- David Shepherd’s 15F 3052 has yet not had accident repair work done, but inspection is due this week. Regardless of visible damage, the axles need to be crack tested anyway.
- 15F 3052’s Brake Ejector had swapped been for FotR’s similar unit from their 19D as the original had failed. The temporary replacement has been removed and will be swapped during the week.

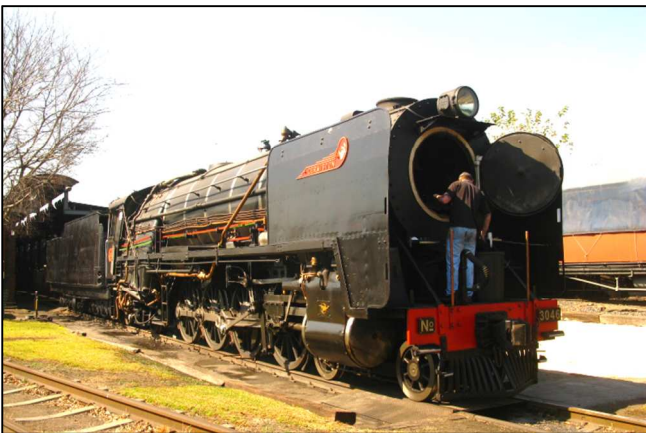
P05 - 15F 3046 Smokebox washout in progress. This was a young people's project today done by Aidan and Kevin.

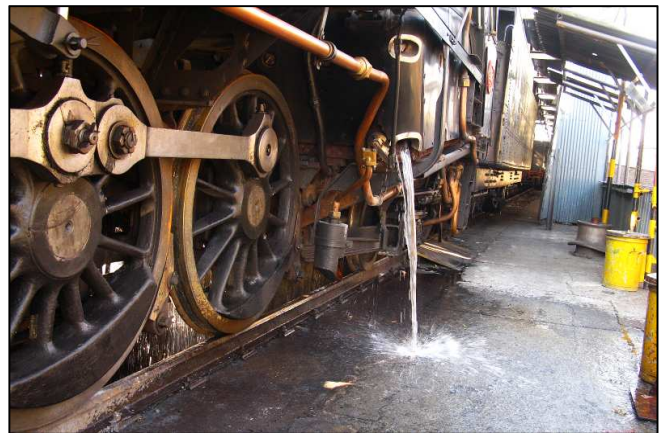
P06 - Early stage of boiler washout in progress. The fellows had yet to start raking out the foundation ring area.

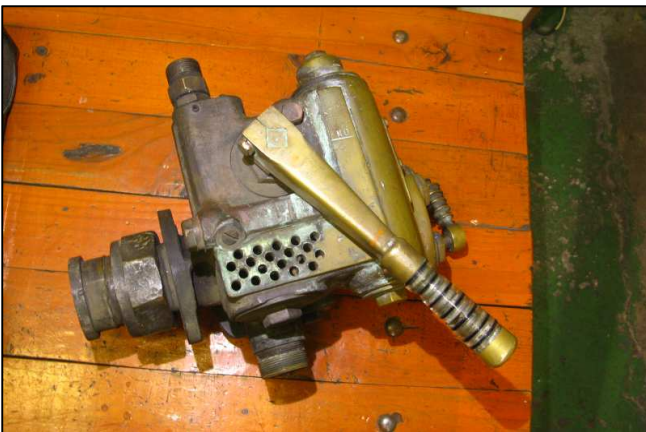
P07 - Brake Vacuum Ejector on its way back to FotR and 15F 3052's faulty unit to be returned.

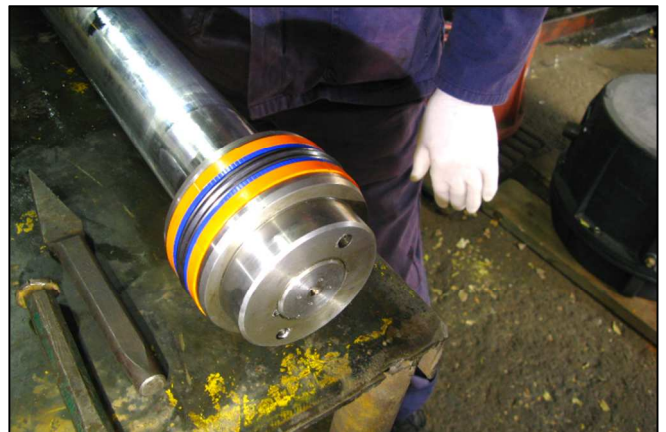
P08 - Brightly coloured hydraulic seals and spacer rings being installed for the extension boom of the coal grab.

- The extension boom’s hydraulic cylinder (The ‘elbow’ joint) has had a full set of seals, spacers and wipers fitted and remains to be reinstalled by the Africa Academy lads.
